IUVA Americas Conference

Investigation of Cause of Quartz Sleeve Hazing In UV/AOP System for Potable Reuse

GWRS Advanced Water Purification Facility

Ultraviolet/Advanced Oxidation Process (UV/AOP)

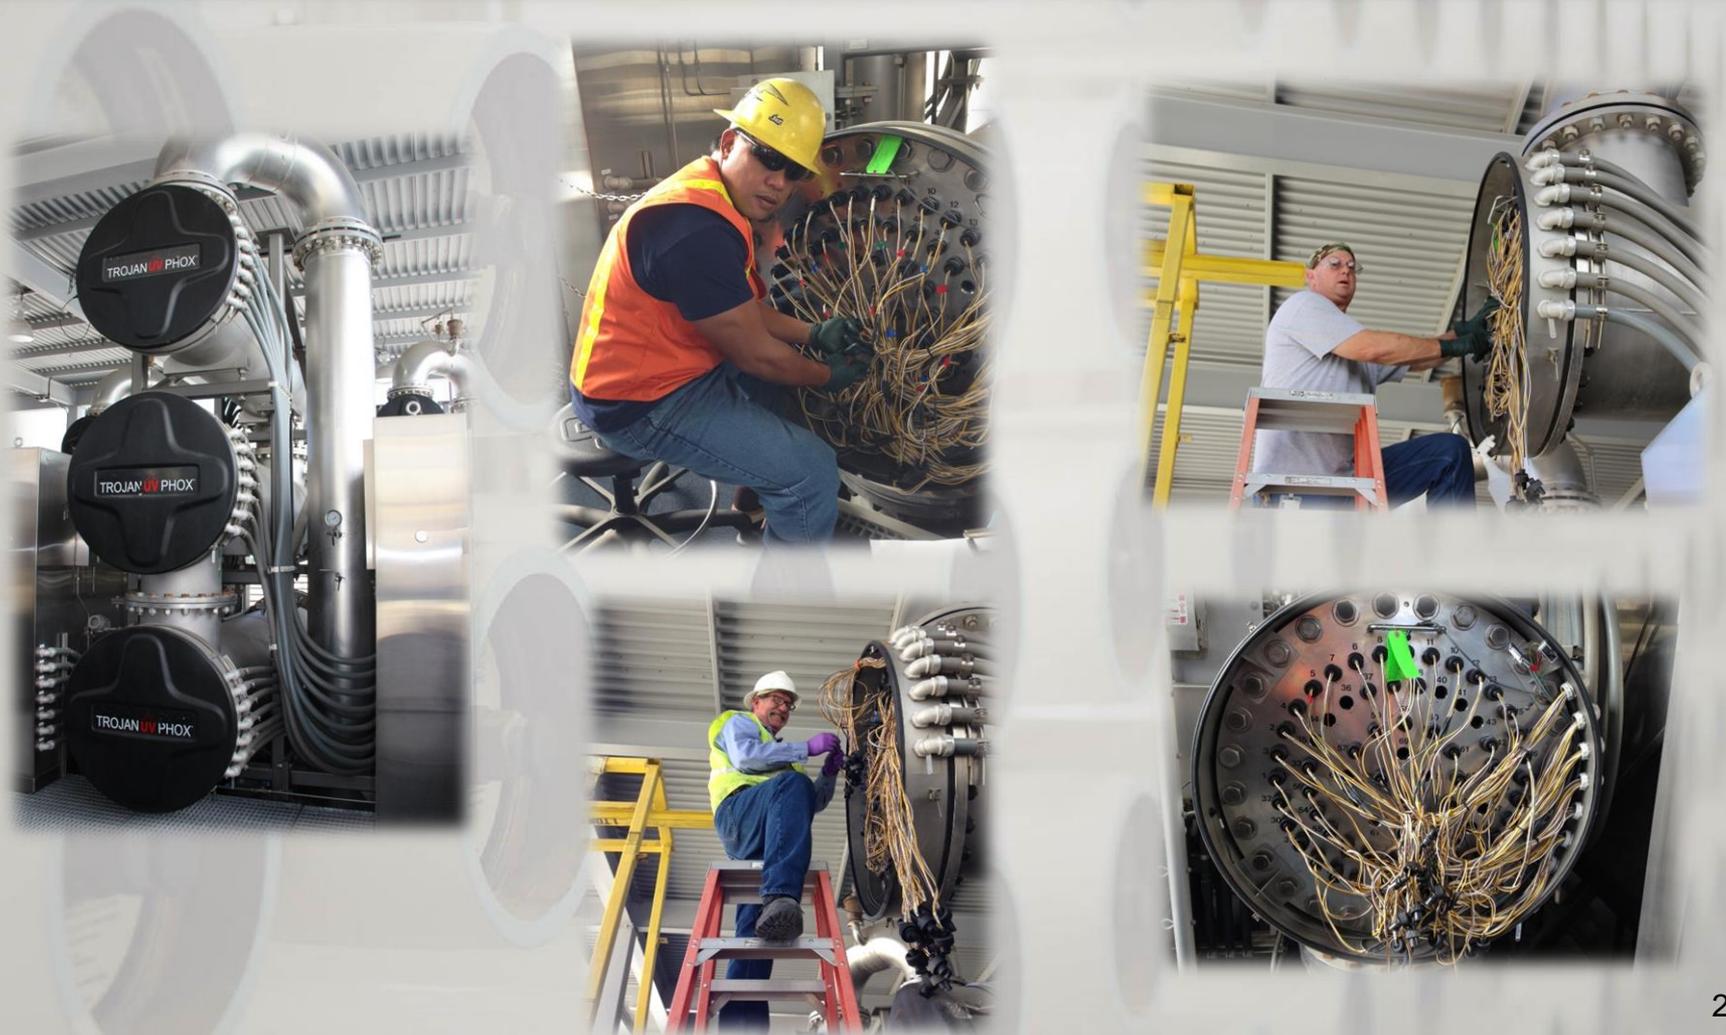
**Microfiltration
(MF)**

**OCSD
Secondary
Effluent**

**Backwash
OCSD Plant 1**

**Reverse
Osmosis
(RO)**

**Brine
OCSD Outfall**

**Ultraviolet Light
with H₂O₂
(UV/AOP)**

Barrier
**Recharge
Basins**

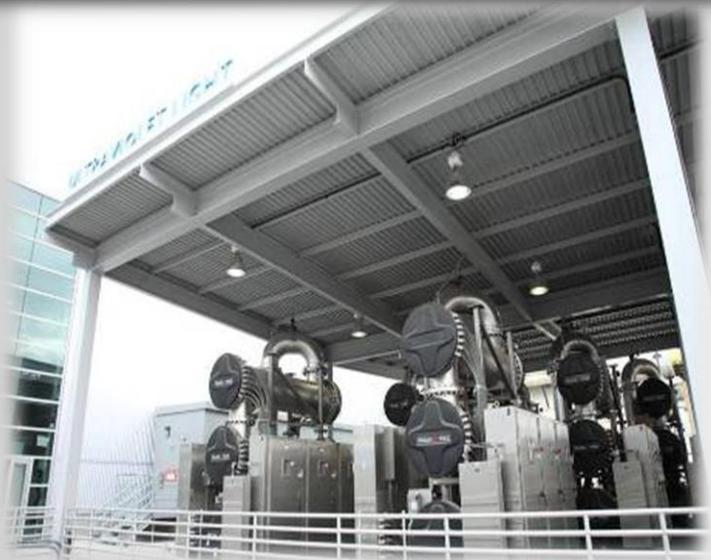
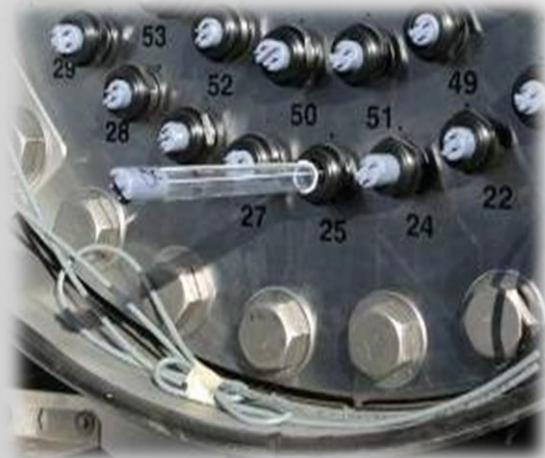
- 100 MGD Trojan UVPhox System
 - 13 trains
- Low pressure – high output lamp system
 - 432 lamps per train
 - 257 watts per lamp, end-of-lamp-life of 12,000 hours
 - Each lamp is housed in a quartz sleeve
- Destroys trace organics
- Uses hydrogen peroxide to create an Advanced Oxidation Process

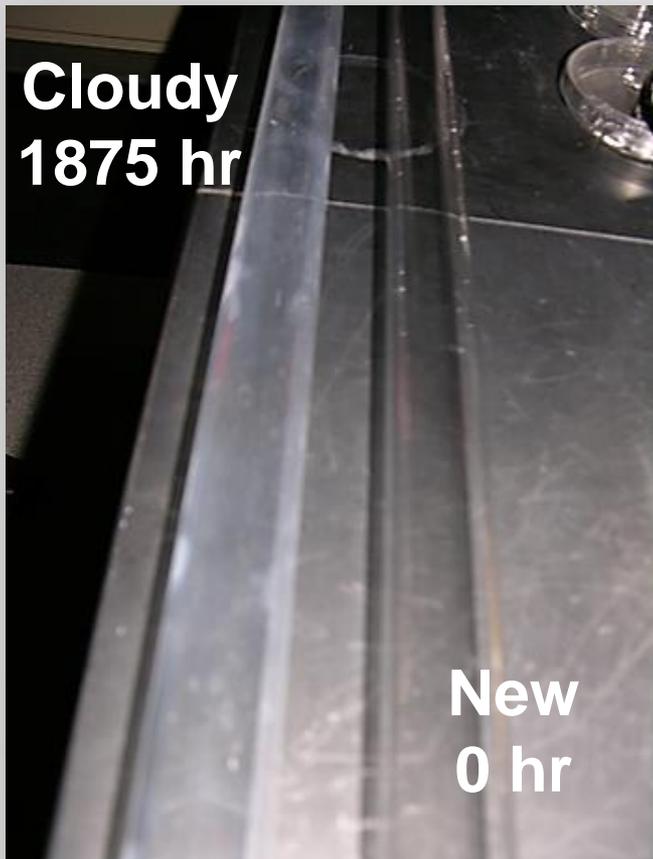
Hazing and Moisture of Quartz Sleeves and UV Lamps

- Study on localized spots showed reduction in UVT varied between **3%, 12% and 20%**

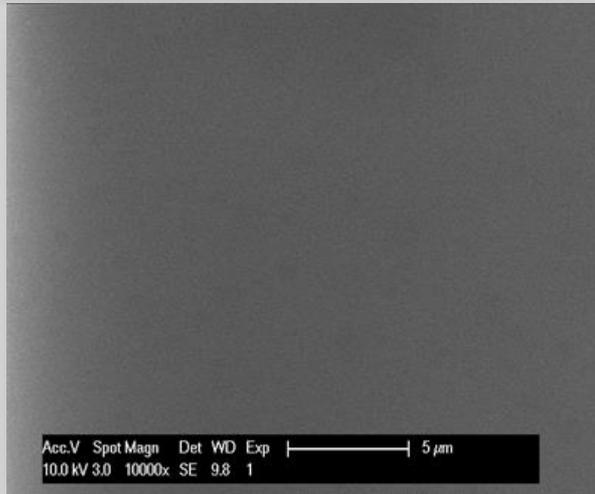
Virgin Quartz Sleeve

<u>Element</u>	<u>Atom %</u>
C	4
O	57
Si	39

- Cloudy quartz surface had egg shell appearance
- Virgin quartz was very smooth with no discernible topographical features
- Only silicon and oxygen on both virgin and cloudy quartz sleeves were detected

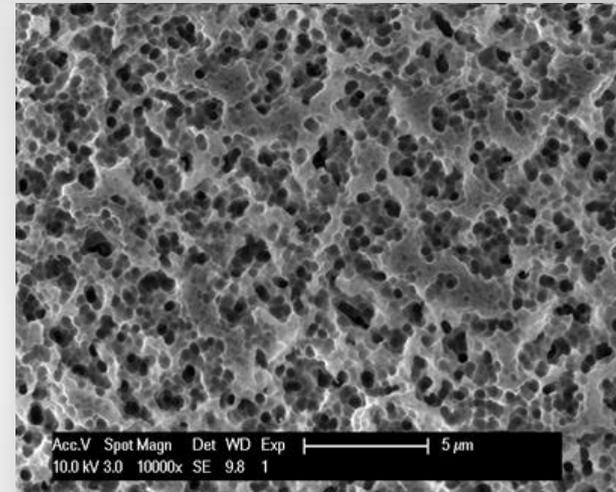
Cloudy Quartz Sleeve

<u>Element</u>	<u>Atom %</u>
C	5
O	60
Si	35

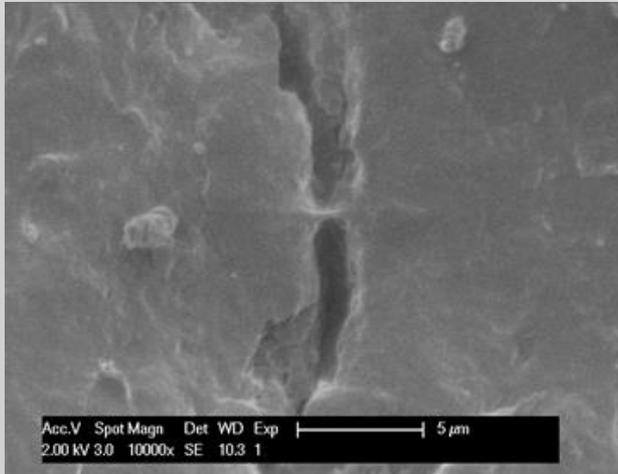
Virgin Teflon O-ring

<u>Element</u>	<u>Atom %</u>
C	63
F	36

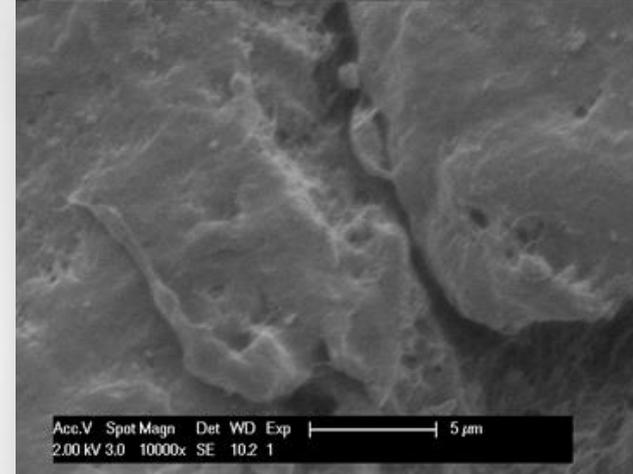
Cloudy Teflon O-ring

EDS Results		<u>Element</u>	<u>Atom %</u>
		C	33
		O	8
		F	59

EDS shows oxygen incorporated on the surface of UV-exposed Teflon, presumably due to oxidation of the polymer

Since moisture seeps into the sleeve during operation, one possibility is that a layer of water condenses on the cooler interior walls of the quartz sleeve, and the HF gas produced from Teflon oxidation is rapidly absorbed into the aqueous condensate etching the quartz surface.

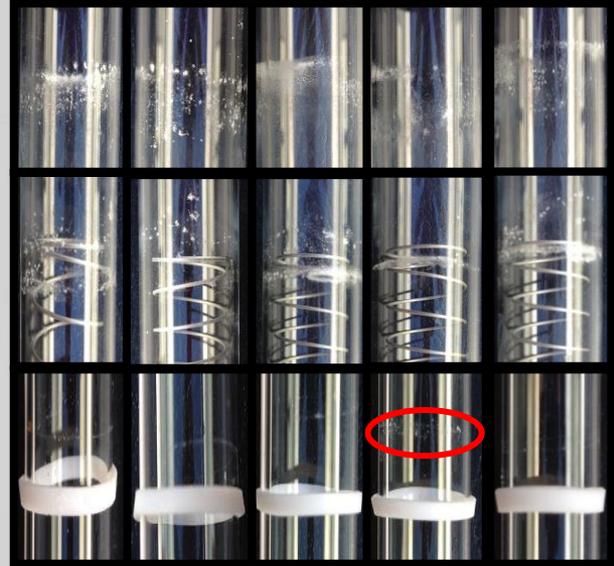
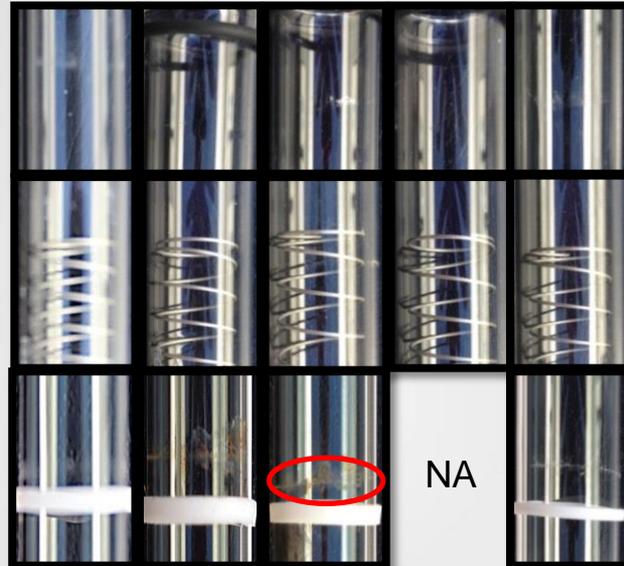
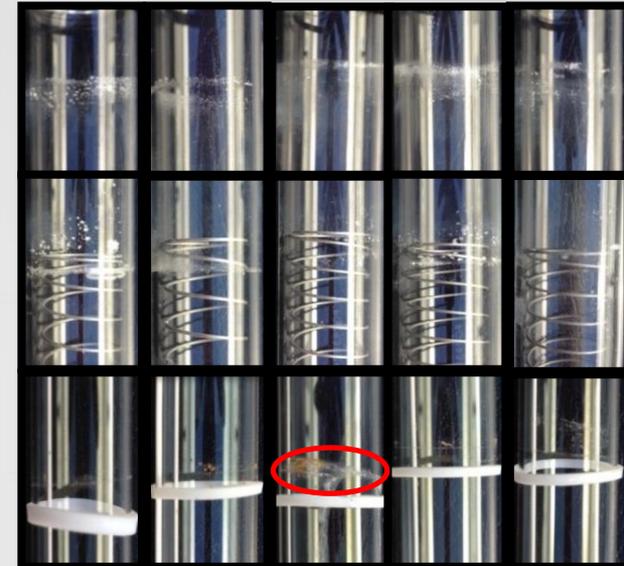
New Quartz Sleeve, 0 hr

New UV Lamp
0 hr

New SS Spring
0 hr

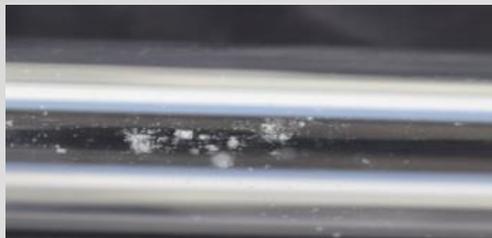
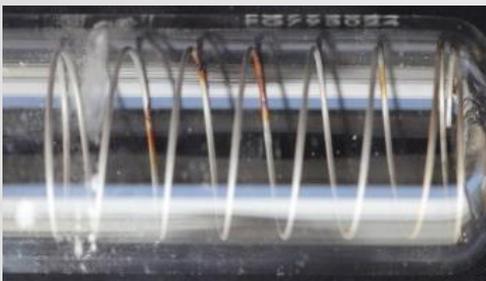
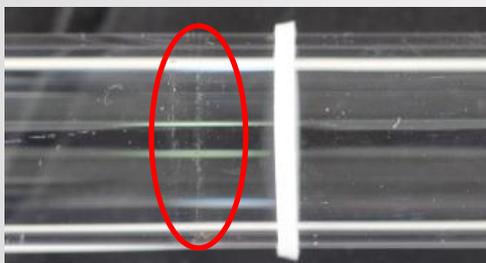
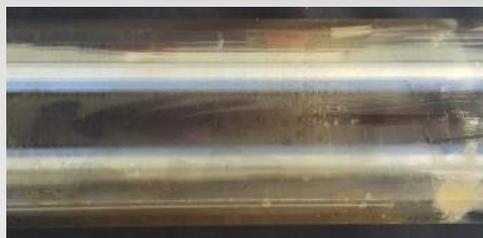
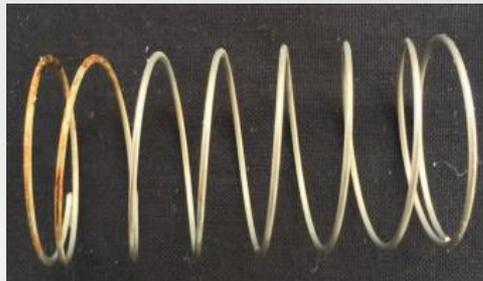
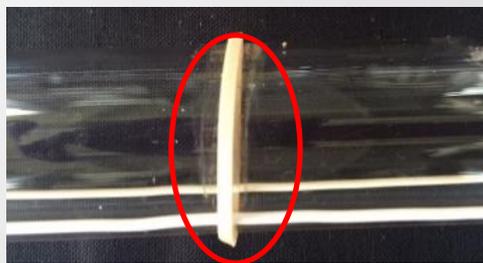
UV quartz sleeves and lamps after 1624 hours of UV exposure

**Control
SOP**

**Wet
1 mL UVP**

- **Control sleeves and lamps** – new sleeves and lamps installed according to standard operational protocol (SOP)
- **Dry sleeves and lamps** – sleeves were purged with nitrogen gas before sealing to test if maintaining a dry environment prevents etching
- **Wet sleeves and lamps** – 1 mL of UV product water (UVP) placed in the sleeve with the lamp to test if the presence of moisture results in the formation of a corrosive environment and hazing (etching)

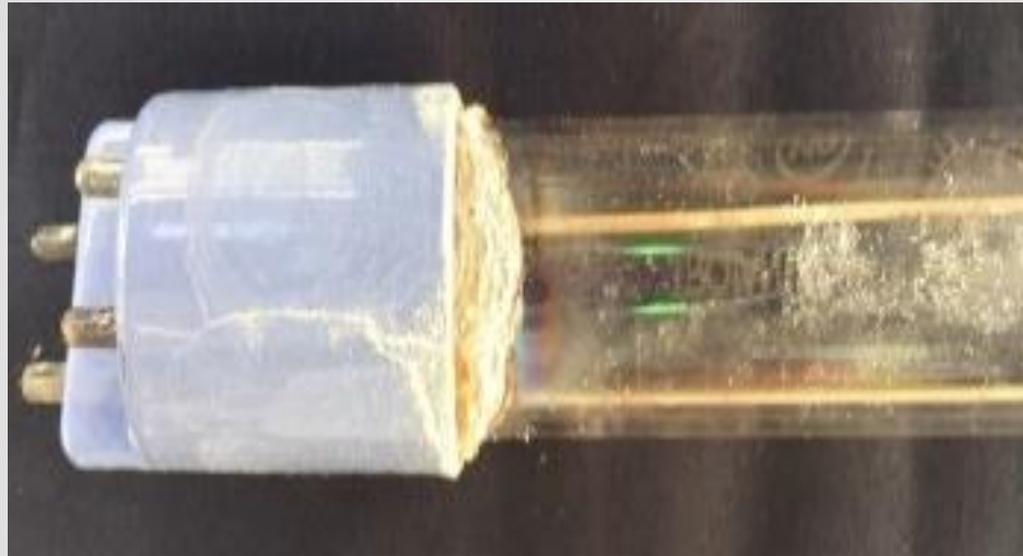
UV Lamp after 7544 hr of UV exposure in wet environment

- Increasing the moisture volume in the quartz sleeve appears to dilute the HF resulting in reduced quartz sleeve etching
- Etching of the UV lamps was only observed in locations where the Teflon O-rings came in contact with the lamp surface

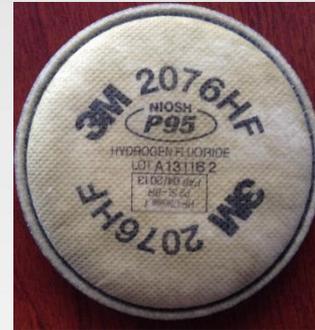
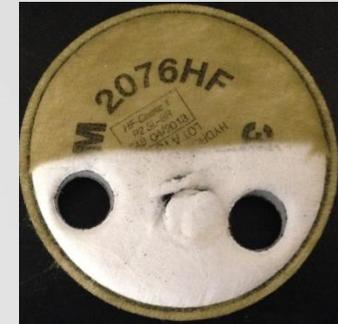
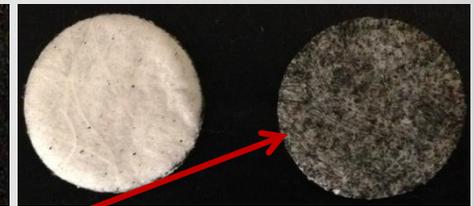
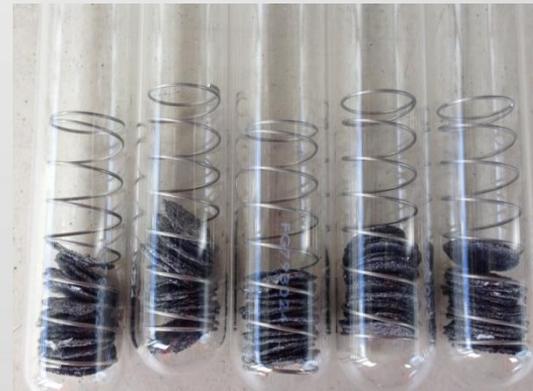
Absorbent

- Thermal degradation of Teflon O-rings leads to HF generation resulting in quartz sleeve etching.
- Addition of HF neutralizer/absorbent was added to prevent the build-up of acid inside the quartz sleeve.

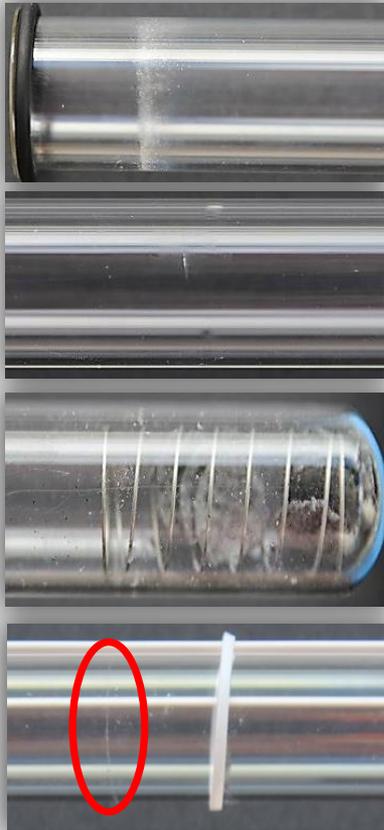
1781 hr

- HF absorbent was effective in preventing significant hazing
- Hazing was only found near the sleeve openings and ends with stainless steel springs
- Lamp etching was minimal at the Teflon O-ring locations
- HF absorbent broke down after long UV exposure

- The use of an HF absorbent can be an effective method in preventing quartz sleeve etching. Due to the short life of the HF absorbent under UV conditions, this method is not practical

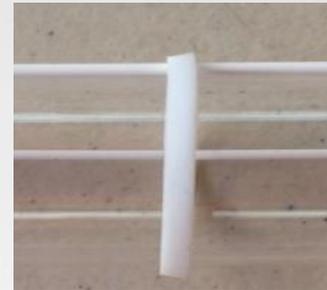
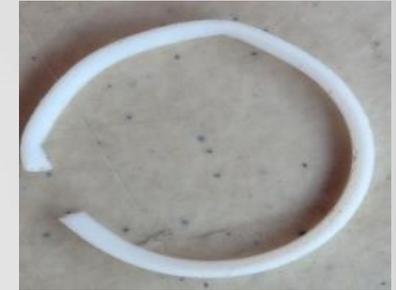
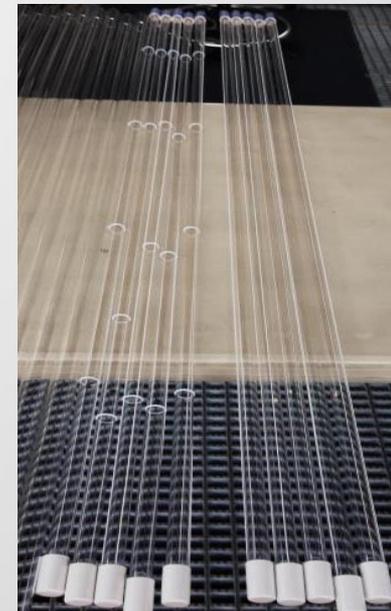
- Removed Teflon O-rings prior to lamp installation
- Lamps installed according to SOP

37	38	45	57	72
UV Lamp					
Quartz Sleeve Open End	NA				NA
Quartz Sleeve Middle					
Quartz Sleeve Closed End					
Stainless Steel Spring

After 5447 hr of UV exposure; no observable etching on either sleeves or lamps

- Removing the Teflon O-rings from the UV lamp surface is an effective method to prevent both quartz sleeve and lamp etching. HF cannot be generated when the fluorinated polymer, Teflon, is not present.
